Little White Schoolhouse
26951 Barkley Road
Conifer, Colorado

**Historic Structure Assessment
and
Preservation Plan**

Completed by the Center of Preservation Research

Final Report August 2015

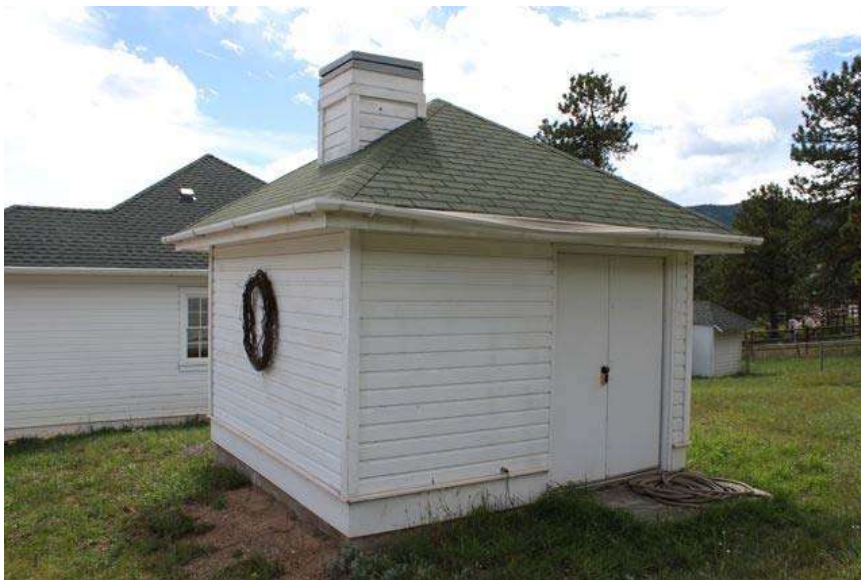
Photo 16: North and east elevations of the pump house. Note the location of the building in relation to the schoolhouse (left of photo), and barn (right of photo). An entry hatch is located on the east slope of the roof, and mimics the look of a chimney. Note the sagging gutter.

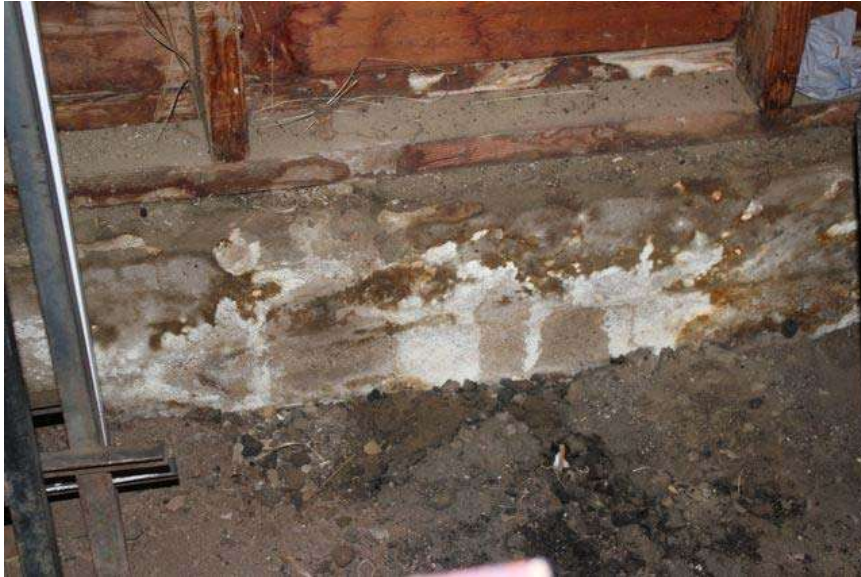
The Barn foundation is in fair condition with significant efflorescence and water damage along the north elevation where the foundation is exposed on the interior. [Photo 19] This area is completely underground. There is a crack with displacement in the middle of the door foundation. [Photo 20] There are small cracks and missing material in the northwest corner. [Photo 21] A large hole is present in the northeast corner where the foundation steps down. [Photo 22] A large crack is located approximately 3 inches from the southeast corner on the south wall. [Photo 23]

Photo 19: Significant efflorescence and water damage along the foundation on the north elevation of the barn.

- Remove excess mulch and re-grade play area to allow for a lower play yard that doesn't get in the way of the view on approach. (All buildings)
- Waterproofing should be considered for the exterior of the north foundation wall of the barn. Full waterproofing may be cost prohibitive, but at a minimum a swale should be created several feet from the foundation to promote drainage away from the foundation. (Barn)

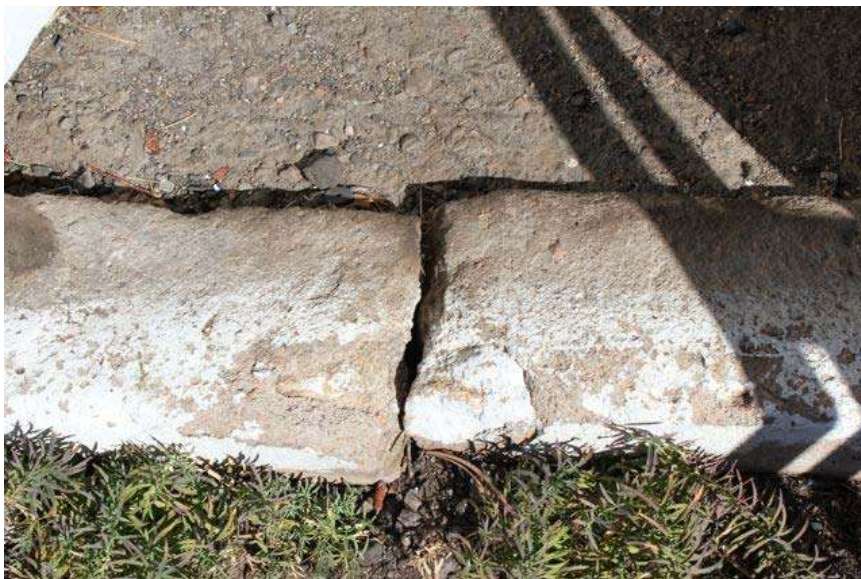
Photo 20: A foundation crack with displacement in the middle of the barn door.

- Monitor cracks in the barn foundation to ensure they are not increasing in size. (Barn)
- Replace the fence to meet current code requirements in terms of height and spacing of pickets. (All buildings)

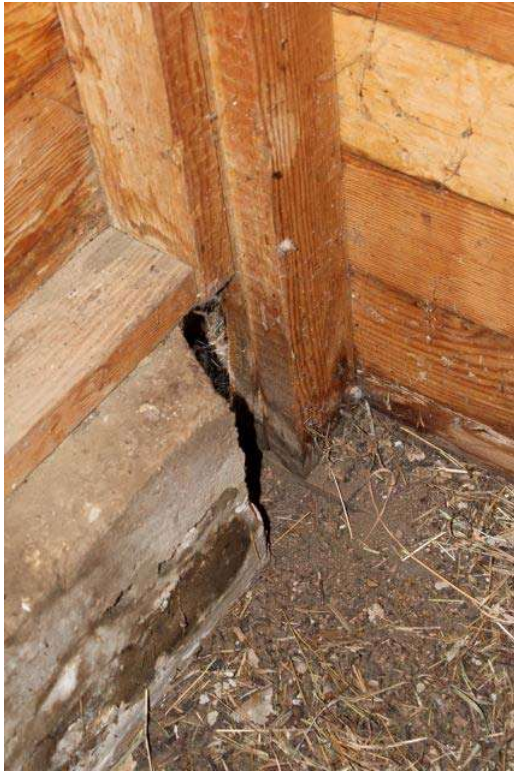
Photo 21: Small cracks and missing material in the foundation at the northwest corner of the barn.

- Infill repairs of missing concrete on the northeast and northwest corners should be completed using a mixture of new concrete compatible with the existing material. (Barn)

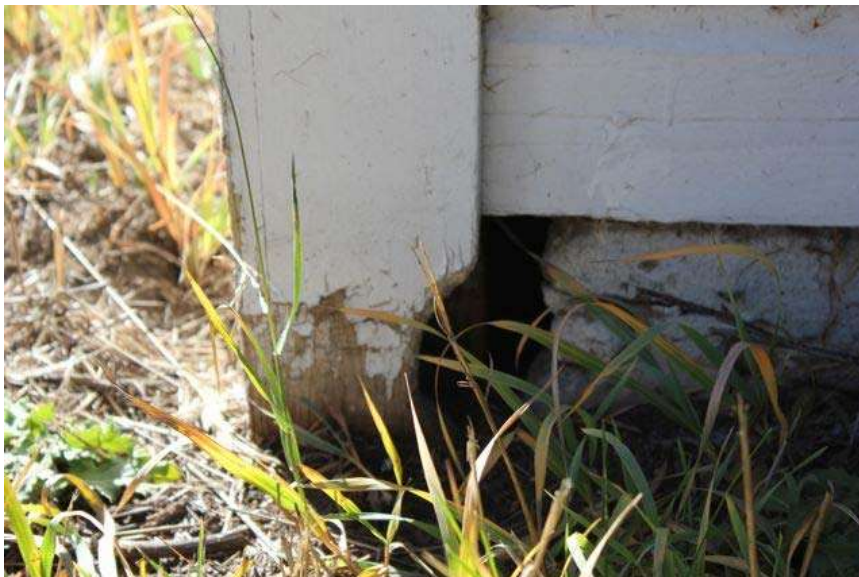
Photo 22: A large hole is present in the northeast corner of the barn where the foundation steps down.

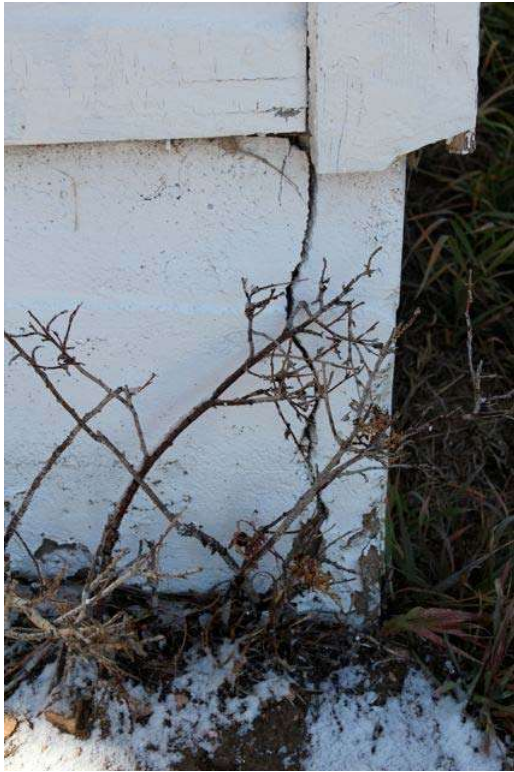
Photo 23: A large crack in the barn foundation on the south elevation approximately 3 inches from the southeast corner of the building.

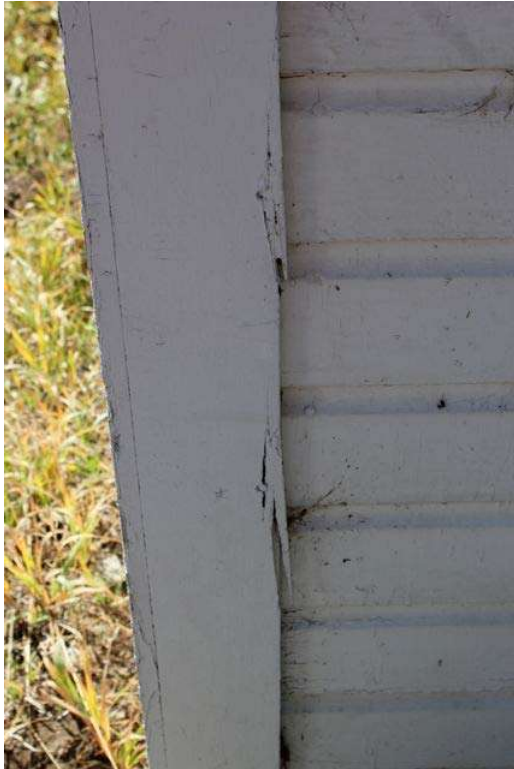
The Barn siding and trim are in fair condition. The northeast trim board needs replacement. [Photo 26] The lowest siding board on the north elevation of the privy on the west is damaged due to snow build up and needs to be replaced. Approximately 10 percent of the siding boards have material damage and require replacement. [Photo 27] The siding around the windows has been cut to accommodate the window installation, which were not part of the original construction. [Photo 28] Water staining was apparent in many locations on the interior surface of the siding as well as gaps visible through the siding. The roofing is in good condition. The exposed rafter ends and eaves are in fair condition. Lacking the protection of gutters and downspouts, they have been exposed more to weathering than those at the schoolhouse. The northeast corner in particular is in the worst condition. The windows are in poor condition, but are restorable. The window on the east is in the best condition with extant mullions but no glazing. The door is in fair condition, the construction of it is quite unusual, but the reason for it is not known. The door has exterior finish and paint problems, damage to the panels and missing hardware. Mouse droppings were observed throughout the interior of the barn.

Photo 26: Trim boards along the northeast corner on the barn.

- Sister the header over the door to provide further support for the trussed rafter. (Barn)
- Damaged trim boards and siding on the barn should be replaced with like material. (Barn)

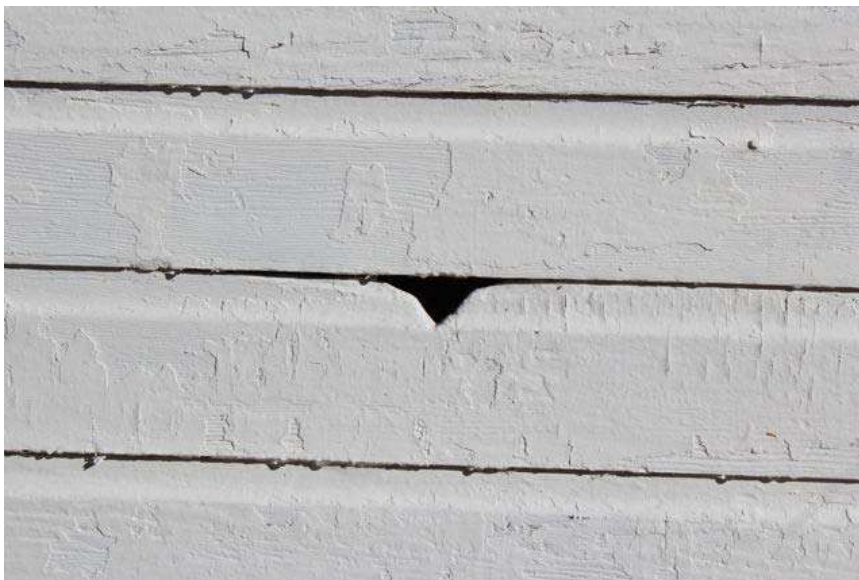
Photo 27: Barn siding shows damage and poor preparation for the last paint job.

- After all repairs have been completed, all loose existing paint should be removed, the substrates scraped to a smooth surface, repaired with epoxy consolidant where necessary, primed and repainted. All wood surfaces should be primed with a high quality oil-based wood primer and then top coated with two coats of acrylic latex or oil-alkyd paint. (Barn and Pump House)

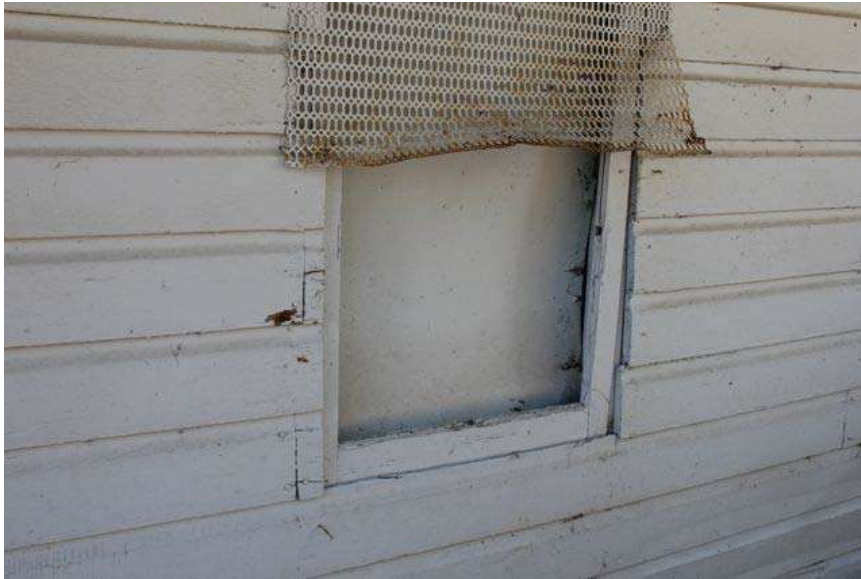
Photo 28: Siding around windows in the barn has been cut to accommodate the window installation, which were not part of the original construction.

- Repair exposed rafter ends and eaves. (Barn)
- Trussed rafters should be strengthened at each panel point. (Barn)
- Fill gaps around the windows on the barn where the siding has been cut to accommodate window installation. (Barn)

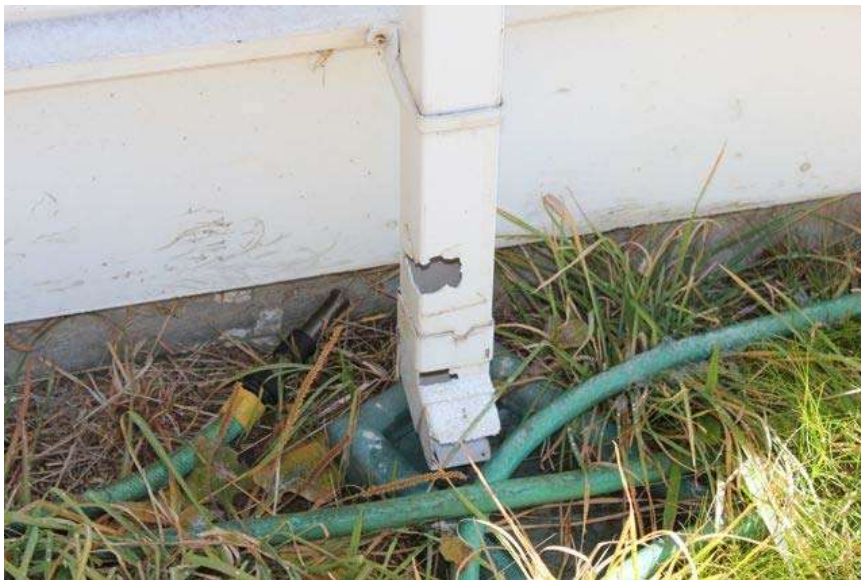
Photo 29: Broken downspout on the pump house.

- Repair gutters on the pump house, or replace them with metal gutters and downspouts that are able to withstand heavy snow. (Pump House)
- Replace the sill plate if further investigation indicates water damage. Repair any framing which is also shown to have damage. (Barn)

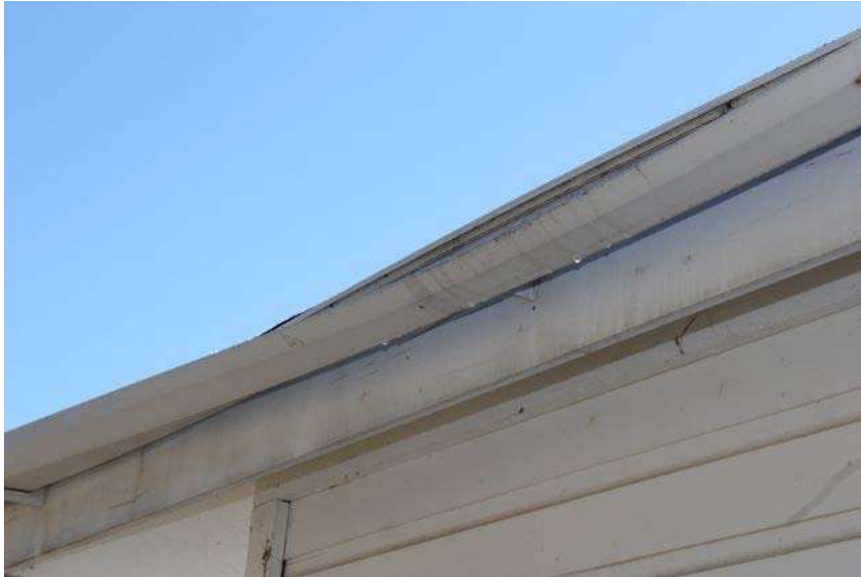
The pump house foundation and roof are in good condition. The siding and trim are in fair condition. The paint is showing general signs of weathering. The upper fascia boards are splitting in places on the west and east elevations. Small chunks of wood are missing from the siding and trim boards on the south elevation. The bottom of the downspout is broken. *[Photo 29]* The gutters are in fair condition. A gutter hanger has broken on the north elevation, and the gutter is sagging badly. The poor spacing of the hangers also contributes to the condition of the gutters. *[Photo 30]*

Photo 30: A sagging gutter on the pump house due to a broken gutter bracket.

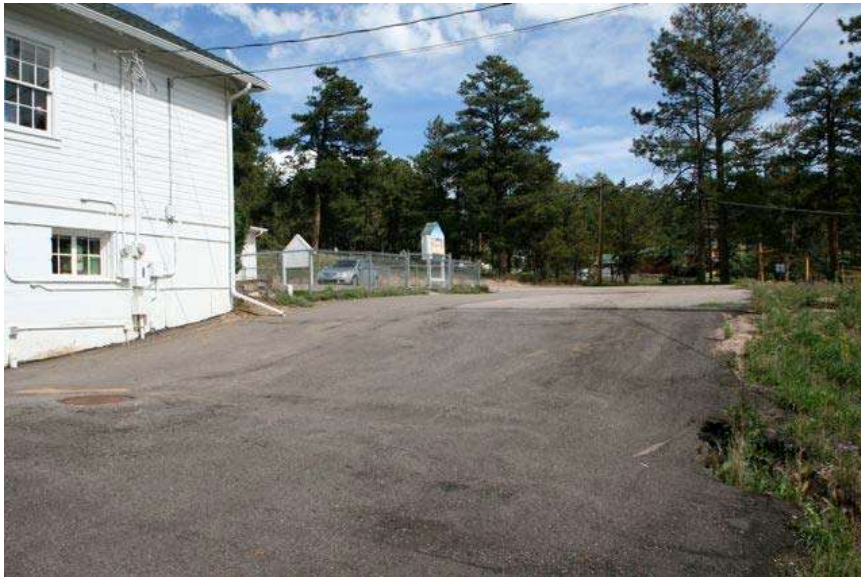
Photo 33: The southwest portion of the parking area is located at the bottom of a slope. This drive provides fire and service access to the basement of the building. Note that the south side of the parking area has eroded due to excessive drainage.

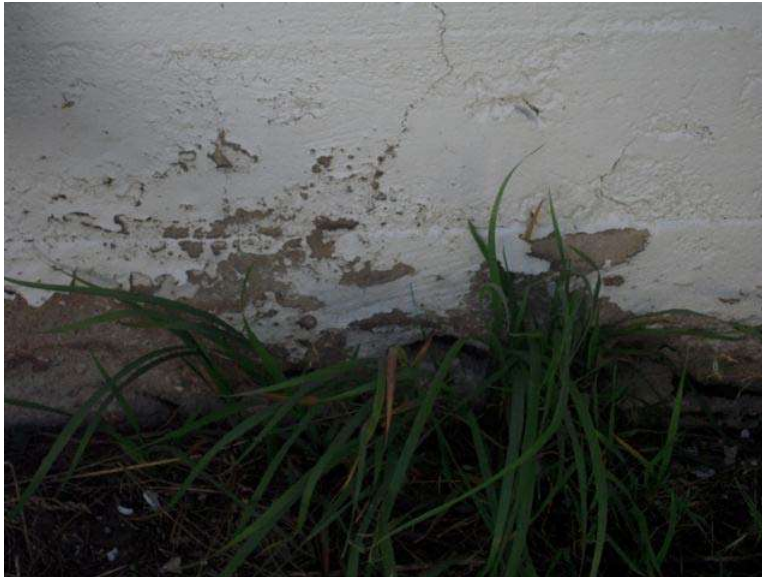
Photo 34: Spalling of concrete and loss of paint along the west wall due to scouring of water flowing along the adjacent slope.

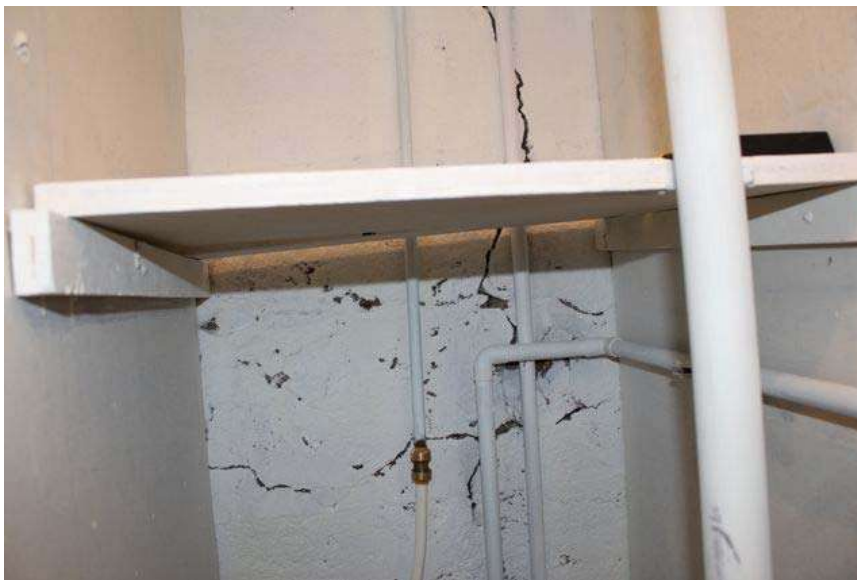
Photo 35: Cracking extending from the corner of the boarded up window along the west elevation. This view is from inside the basement room between the boys and girls bathrooms.

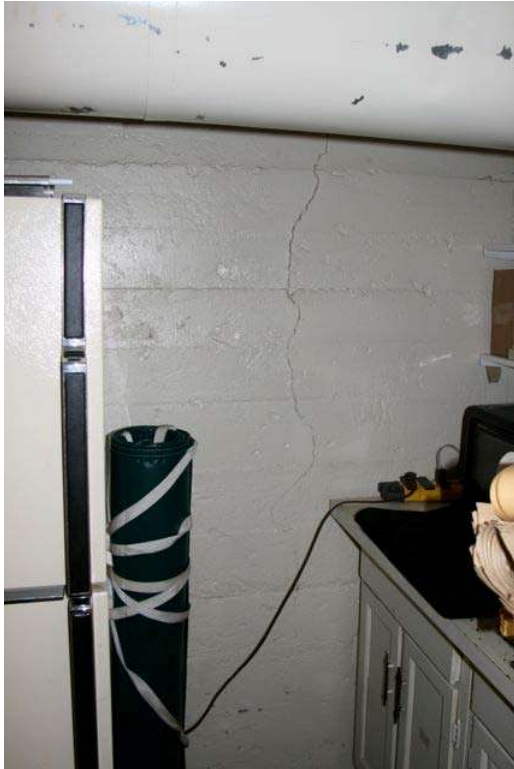
Photo 36: Vertical crack in the basement along the east wall.

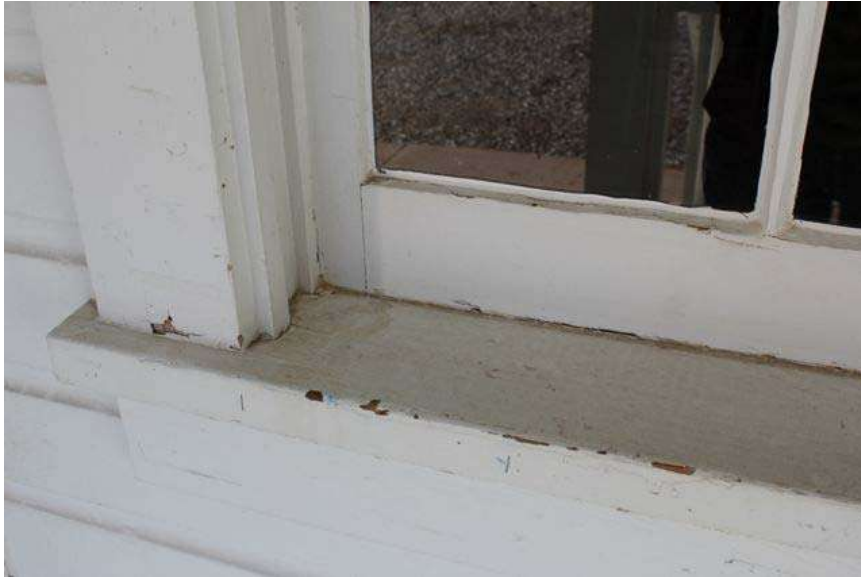
Photo 40: An exterior window shows weathered paint.

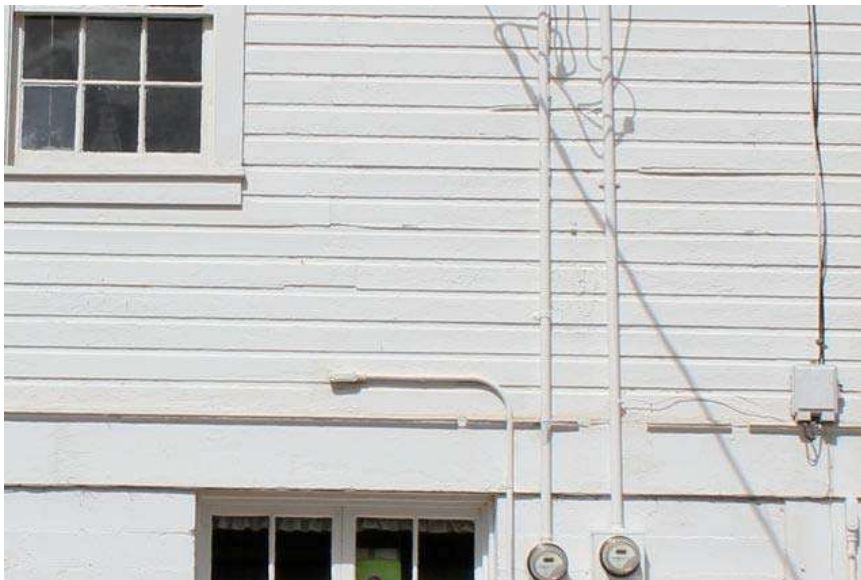
Photo 41: Damage along the south elevation is evident where utilities have been connected, moved and removed.

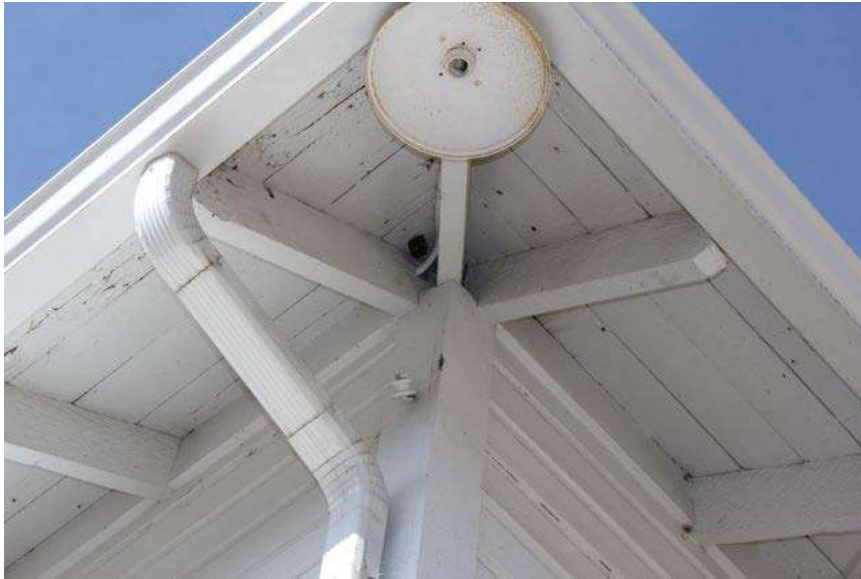
Photo 42: At the north elevation, paint failure is significant near the gutter attachment at the underside of the eaves.

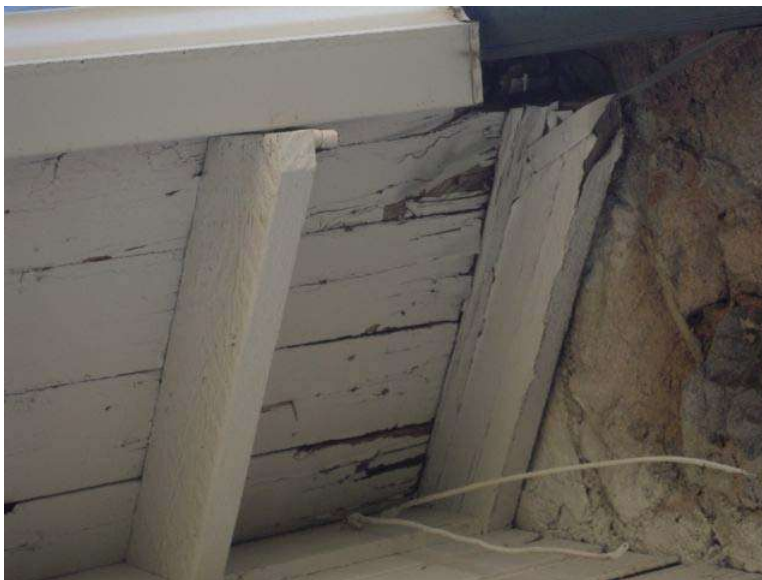
Photo 43: The gutter has been cut back to allow for the 6 inch diameter vent to extend up along the chimney through the eaves. Note the significant damage to the rafter tail and eaves.

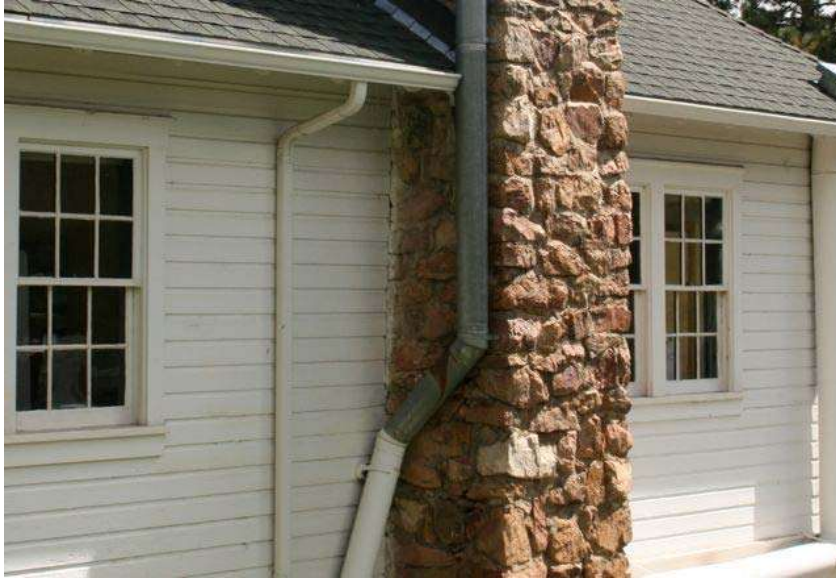
Photo 44: Water drains through a gap between the gutter end and the chimney, deteriorating the vent, the stone and mortar and the wood of the eaves and adjacent rafter tail. Rust stains on the vent pipe indicate where the water runs and the direction it continues to the ground. A vertical crack has developed roughly centered along the projecting north face of the chimney.

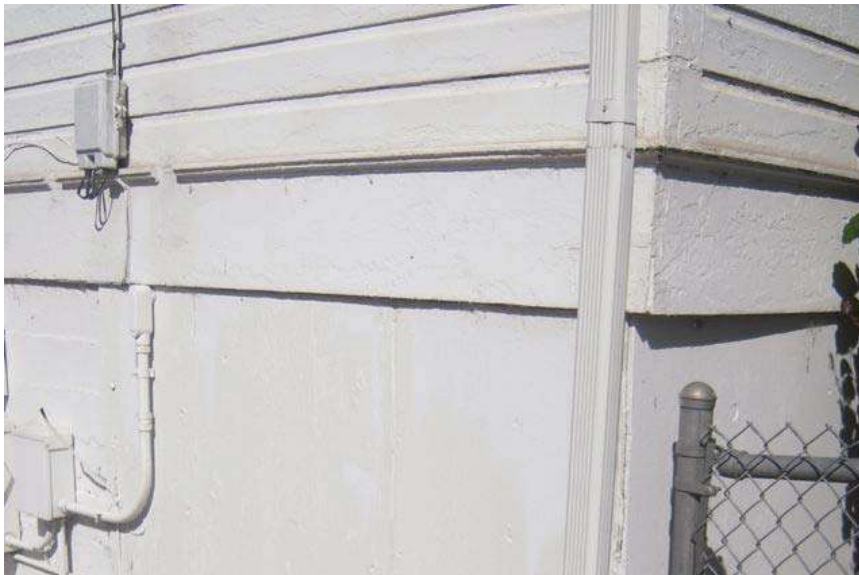
Photo 45: The trim piece between the siding and the water table board has been cut and damaged when utilities have been installed or moved. Notice the peeling paint where poor preparation occurred prior to the last paint job. Also notice the water table boards separating at the corner.

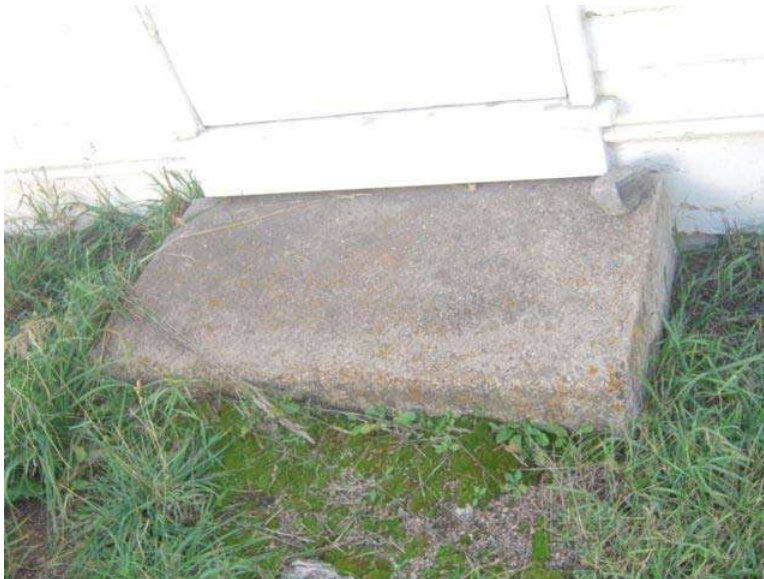
Photo 47: A small concrete stoop located outside the north door. Note the moss growing along the stoop, most likely caused by the slope directing water toward the foundation area.

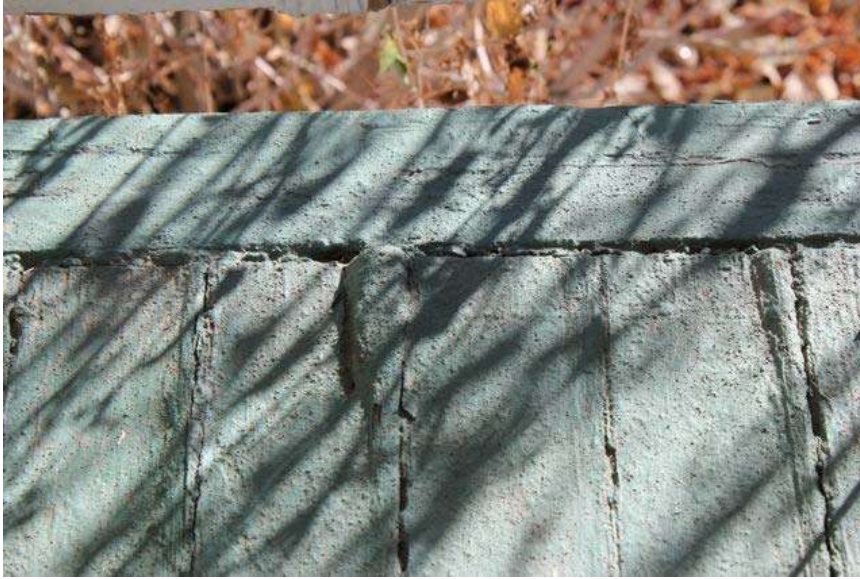
Photo 48: The deck of the porch is covered with 3 ¼ inch tongue and groove flooring that has been painted a dark green. The decking is heaving and uneven in areas where it is exposed to weather.

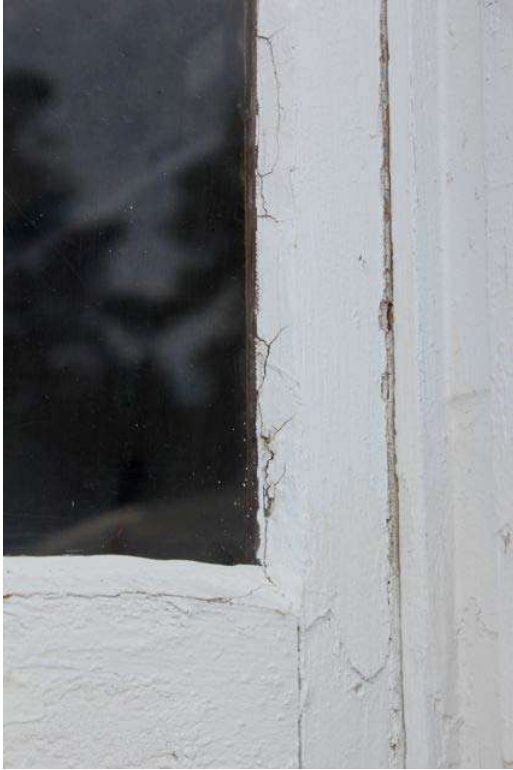
Photo 50: Putty is cracked or missing on the exterior of many windows, and the paint is weathered.

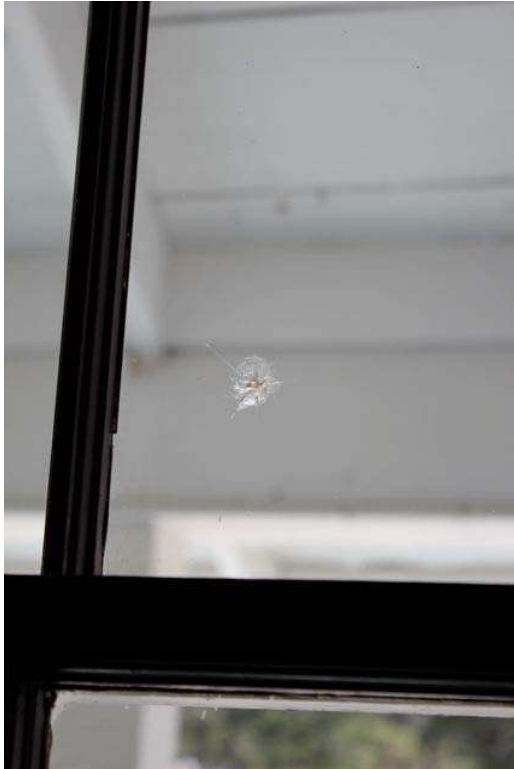
Photo 51: Divot in pane of a window on the east elevation.

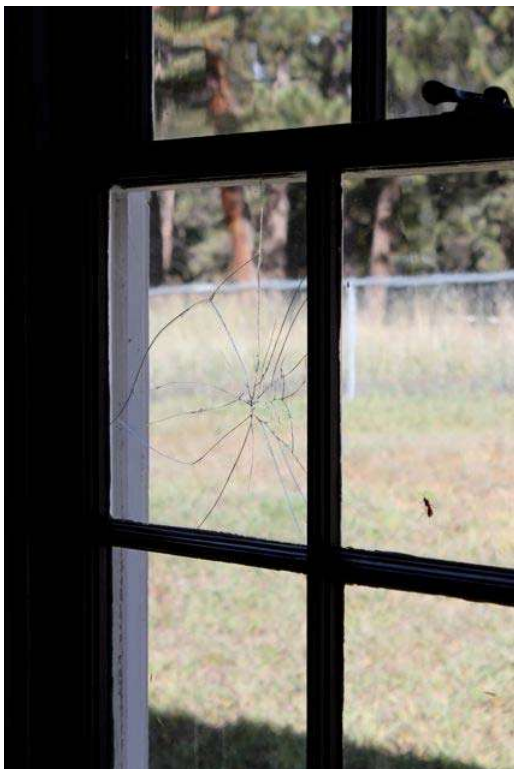
Photo 52: Broken pane on a window along the north elevation.

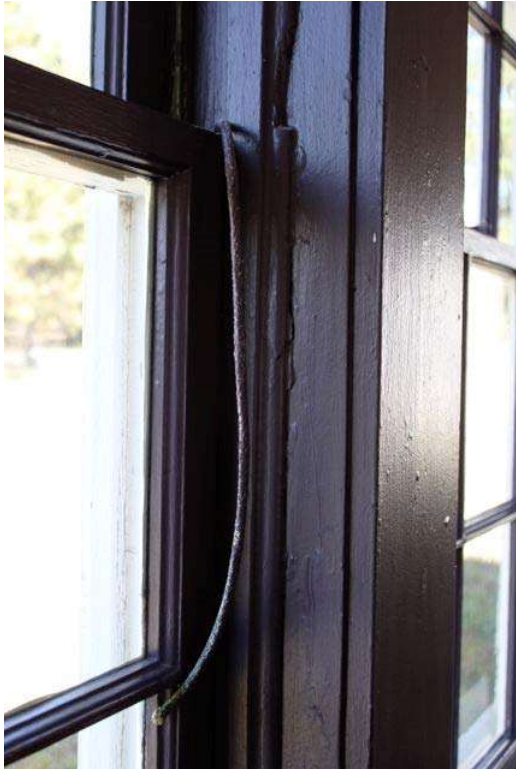
Photo 54: Window along the west elevation has a broken sash cord and a damaged stop.

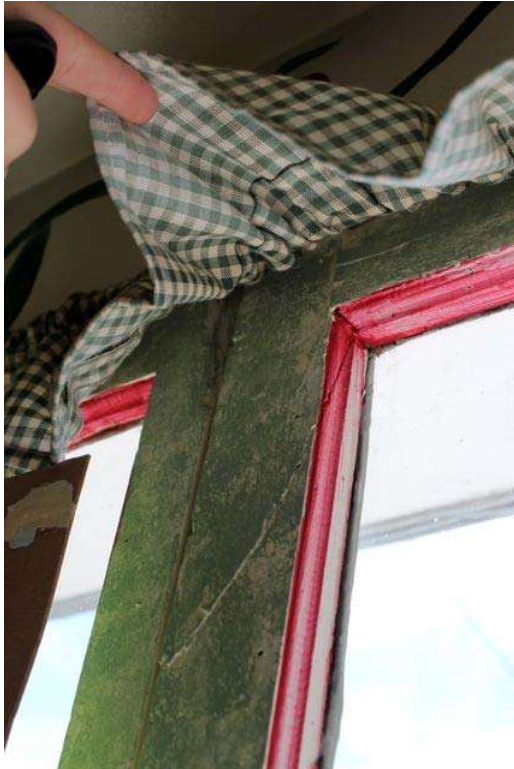
Photo 57: Cracked stile on the basement level casement window on the south elevation.

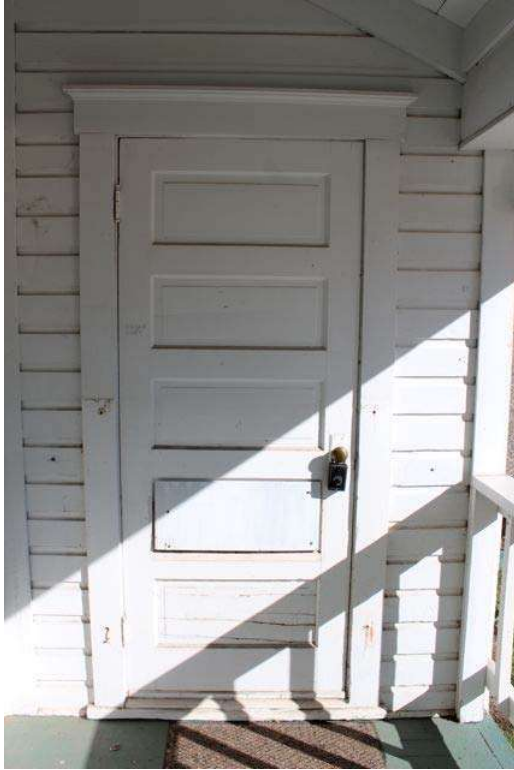
Photo 60: The exterior door leading from the porch to the north cloakroom. This door is nearly identical to the one leading to the south cloakroom. The fourth panel from the top of the door has been fitted with a book drop. The door is weathered, and has cracked panels and nicks and dings.

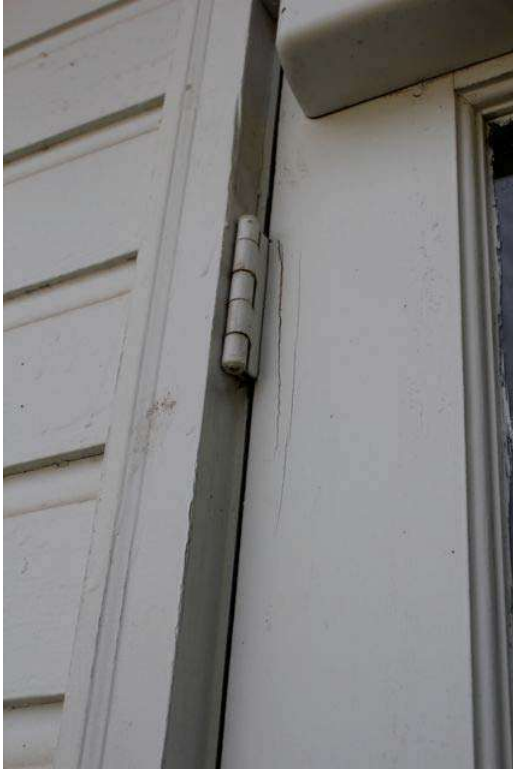
Photo 62: Exterior of the side door along the north elevation. Note the crack in the hinge stile.

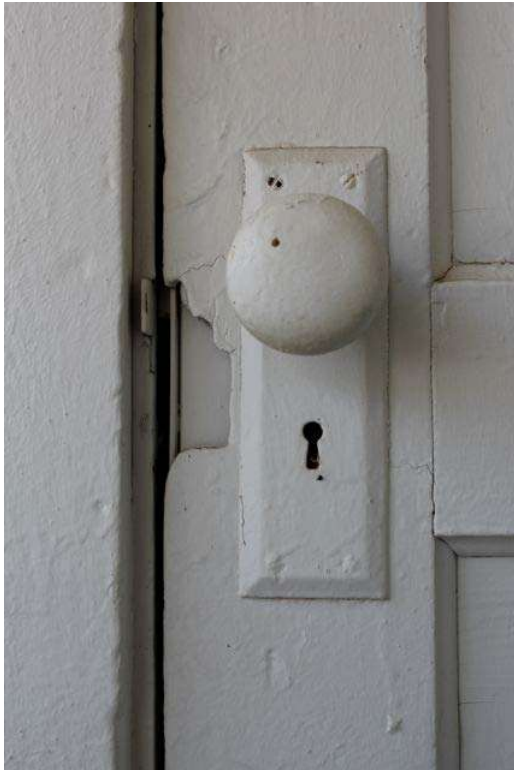
Photo 63: The stile of the exterior south cloakroom door has been damaged, exposing the lock mechanism.

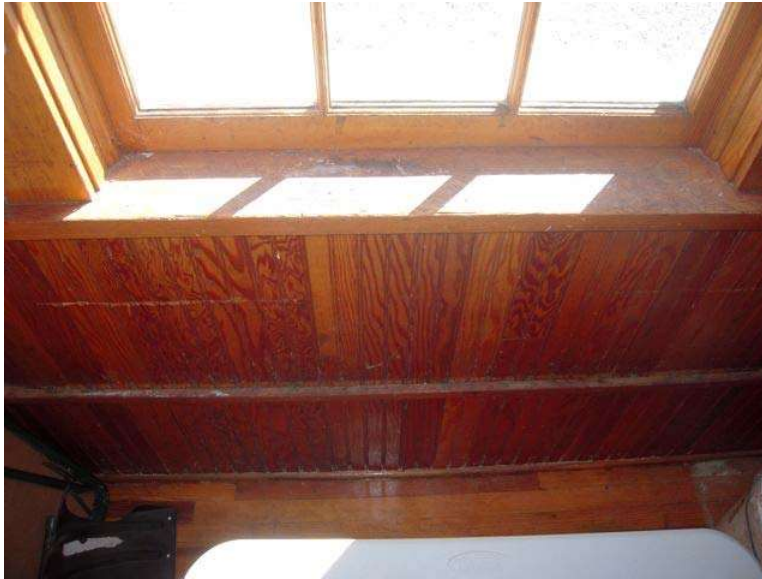
Photo 65: Original stained and varnished wainscoting in the north cloakroom. Note the damage to the wainscot.

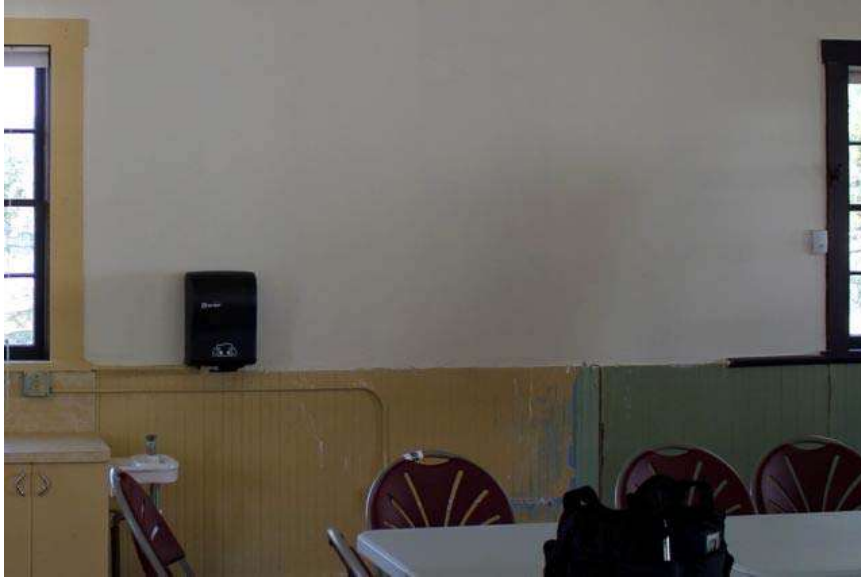
Photo 67: West wall of the main classroom. Note the missing chair rail between the two windows.
