Little White Schoolhouse
26951 Barkley Road
Conifer, Colorado

**Historic Structure Assessment
and
Preservation Plan**

Completed by the Center of Preservation Research

Final Report August 2015

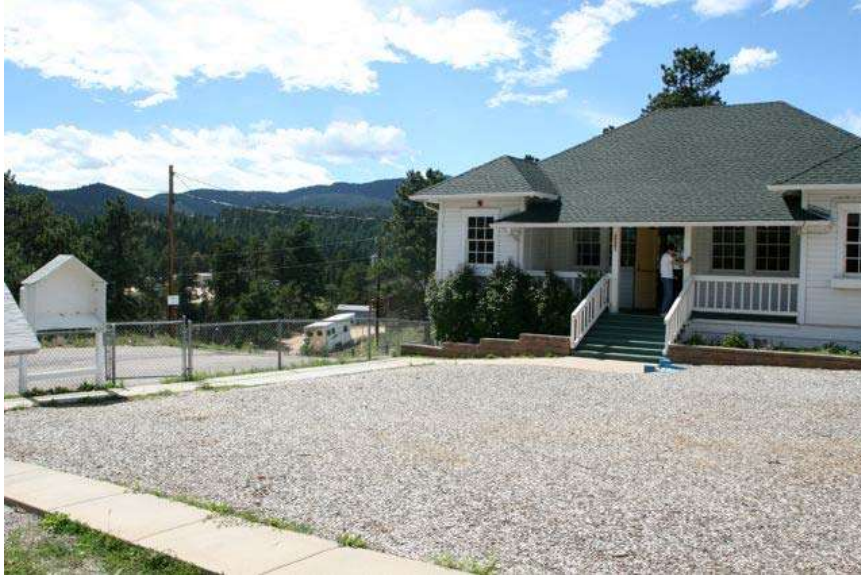
and is only 2 feet 10 inches above the adjacent grade. Approximately 10 percent of the pickets are unsecured and loose. The play yard is in overall good condition, but the build-up of mulch over the years has made it higher than the adjacent grades which could be an issue over time and somewhat detracts from the overall experience of approaching the schoolhouse. The flowerbeds are in good condition. The sidewalks are in good material condition but are too narrow to be a part of an accessible route. See the Accessibility section of this assessment for further information on this condition. The chain link fencing is in good condition. The wood signs are also in good condition. The woven wire and pole fencing is in poor condition along the west elevation where it is partially collapsed and in fair condition elsewhere. However, this fencing is not required or needed for this site so this condition is not of concern.

Photo 9: The play yard is located between the parking area and the front of the schoolhouse. The yard is filled with mulch, and surrounded by fencing.

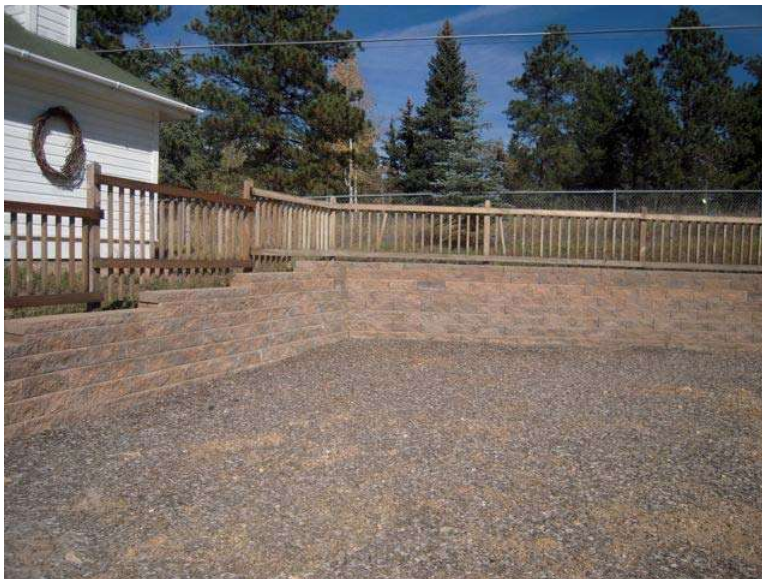
Overall the site is in good condition. The retaining wall is in good condition. The fence on top of the retaining wall is in fair condition and would not be considered to be compliant with today’s building codes. The pickets are spaced too far apart, 4 inches in the maximum allowable, and the fence overall is not tall enough. It should be 3 feet tall

Photo 10: An interlocking masonry retaining wall stretches along the north, east and west sides of the play yard. The wall was built in 2006 to provide a flat area for play equipment. A chain link fence is visible beyond the retaining wall, at the north edge of the property line.

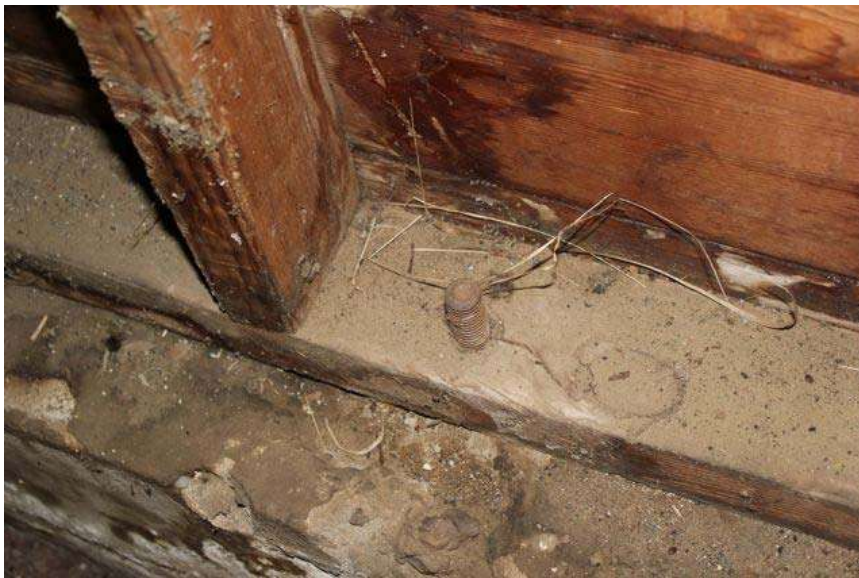
Photo 24: Bolts along the sill plate on the north elevation of the barn.

The Barn framing is in fair condition. There is no visible cross bracing or blocking for the framing. The sill plate is in fair condition with significant deterioration visible along the north elevation which is in poor condition. It appears there are some retrofitted repairs along this area including shims and bolts, which may have been installed to shore up the wall. [Photo 24] This area has more exposure to water due to the slope and location of the foundation. The roof framing is also in fair condition. [Photo 25] The trussed rafters should be strengthened at each panel point. The header over the door, where one of the trussed rafters is supported, is in fair condition and that condition may contribute to the damage to the foundation in this area.

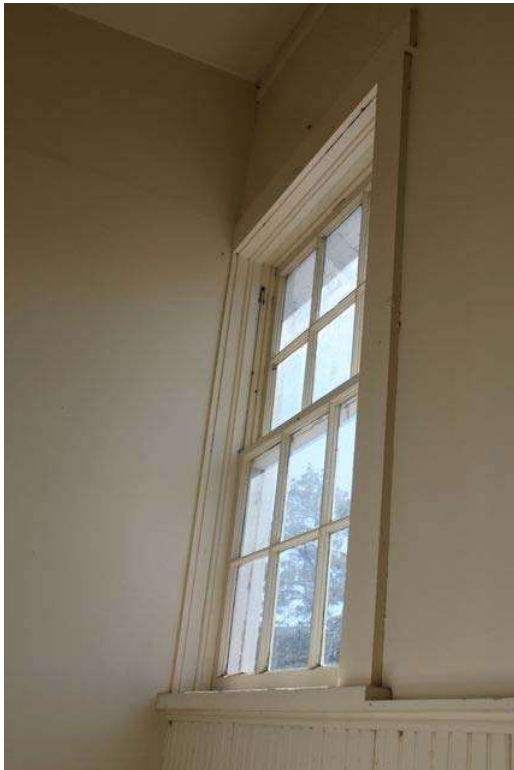
Photo 53: A window facing south appears to have been enclosed in the stairwell.

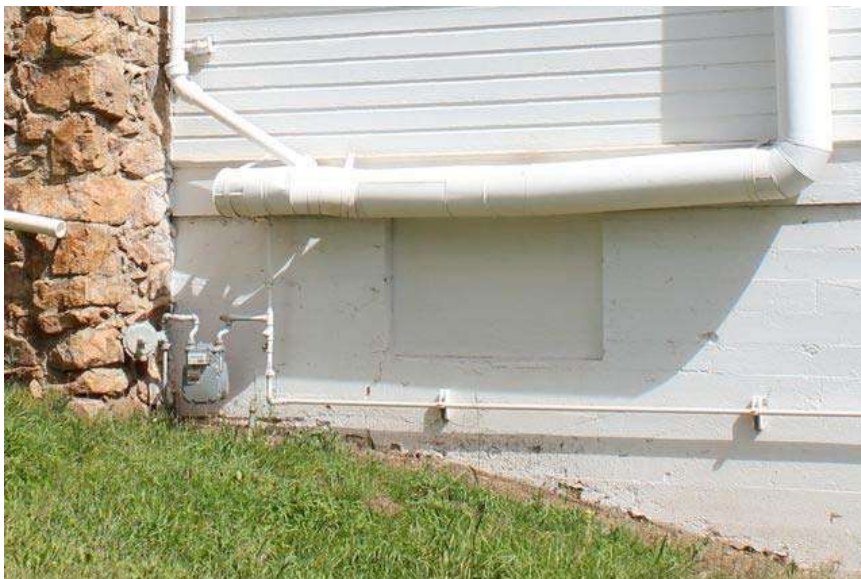
Photo 55: Exterior view of boarded up window on west elevation on basement level.

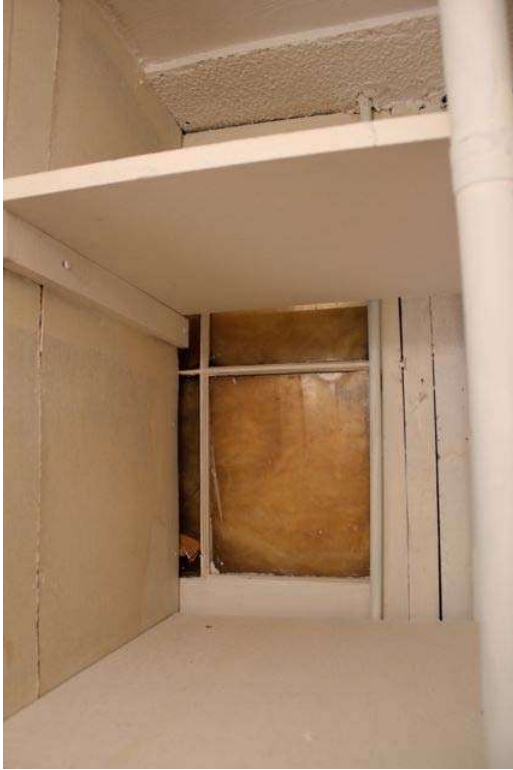
Photo 56: Interior view of the boarded up window on the west elevation at the basement level.

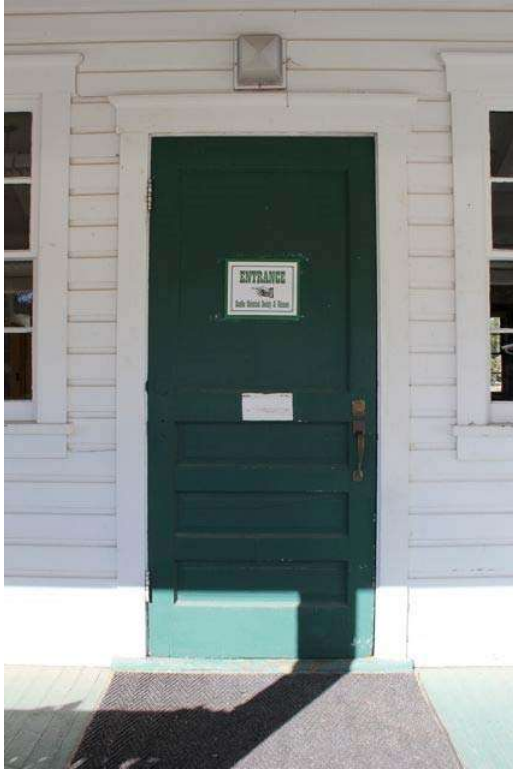
Photo 58: The main entry door appears to have originally contained a window at its top, but the opening has now been filled with plywood. Patches and holes in the door suggest that it once had other hardware, and may have been reversed. The paint is weathered and chipped.

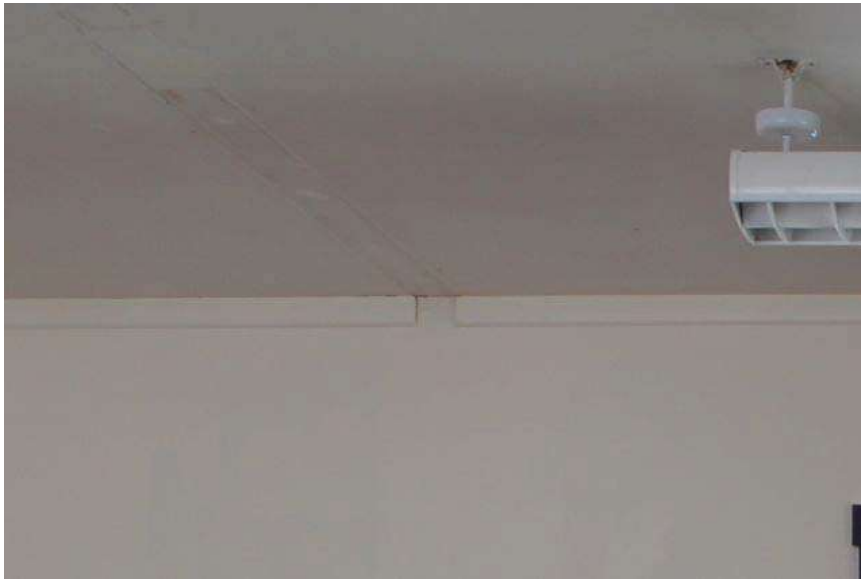
Photo 68: Simple molding between the ceiling and the walls in the main classroom. Note the ghosting along the ceiling and wall from the partition wall that was removed.

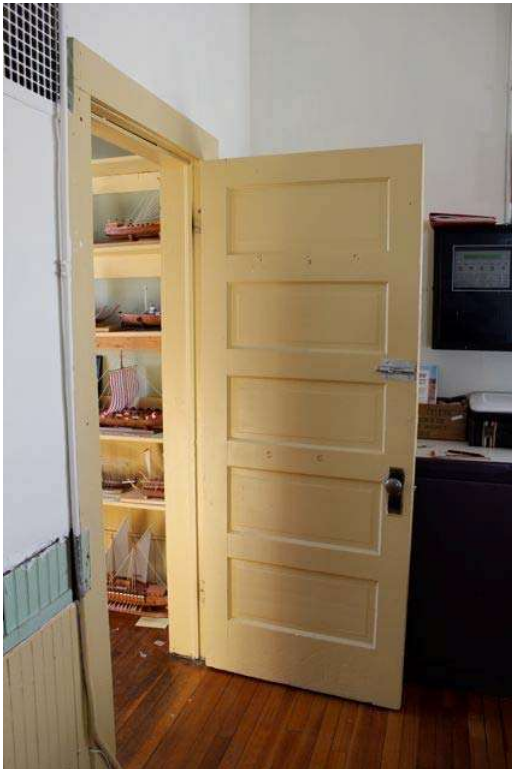
The cloakroom doors are both original. They measure 6 feet 8 inches by 2 feet 6 inches wide and are 1 3/8 inches thick. *[Photo 70]* They have 5 laying raised panels. The south cloakroom door is painted on both sides, the north retains the original stained and varnished finish on the cloakroom side only. The doors are hung on two 5 inch round tipped fully mortised pin hinges which have been painted on the south door. The locksets are standard oil rubbed bronze door knobs and rectangular escutcheons, again painted on the south door. The south door has additional hardware consisting of two sliding bolts.

Photo 70: South cloakroom door. This door is similar to that leading to the north cloakroom.

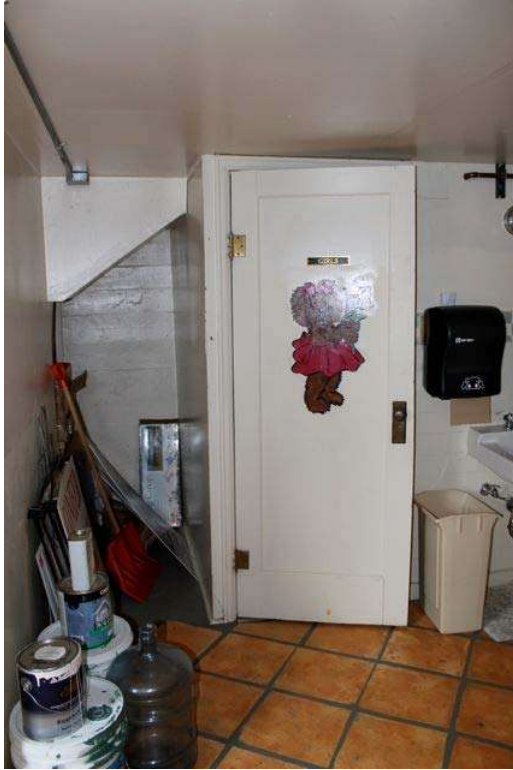
The bathroom doors each measure 6 feet 5 inches by 2 feet 6 inches and are 1 3/8 inch thick. They have a single full panel and are hung on two round tipped 5 inch Griffin brand pin hinges which are half surface mounted. The doorknob and rectangular escutcheon have a brass finish. *[Photo 71]*

Photo 71: The girls bathroom door. The door on the boys bathroom is identical with the exception of the artwork on the door.

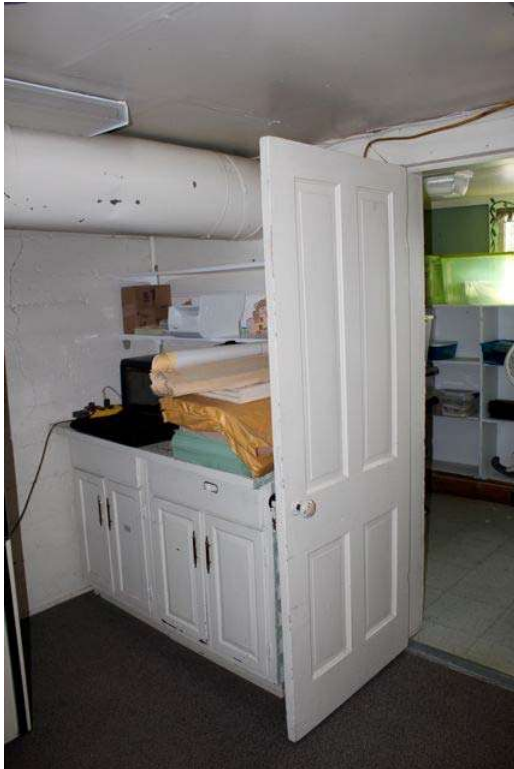
The storage room door is a four raised panel door in a two over two configuration. *[Photo 72]* The door measures 6 feet 4 inches by 2 feet 6 inches by 1 3/8 inches thick. The door is hung on two different style hinges, neither which are original to the opening. The lower hinge is a 5 inch round tip fully mortised hinge which has been painted so the original finish is not visible. The top hinge is a 3 ¾ inch knuckle hinge with fully mortised cast flanges. This is an older style of hinge and is missing the tips. The door

Photo 72: The door to the storage room in the basement is unlike any other door in the schoolhouse. Due to the unique door and hardware, it is possible that this door was moved to the schoolhouse from another building.

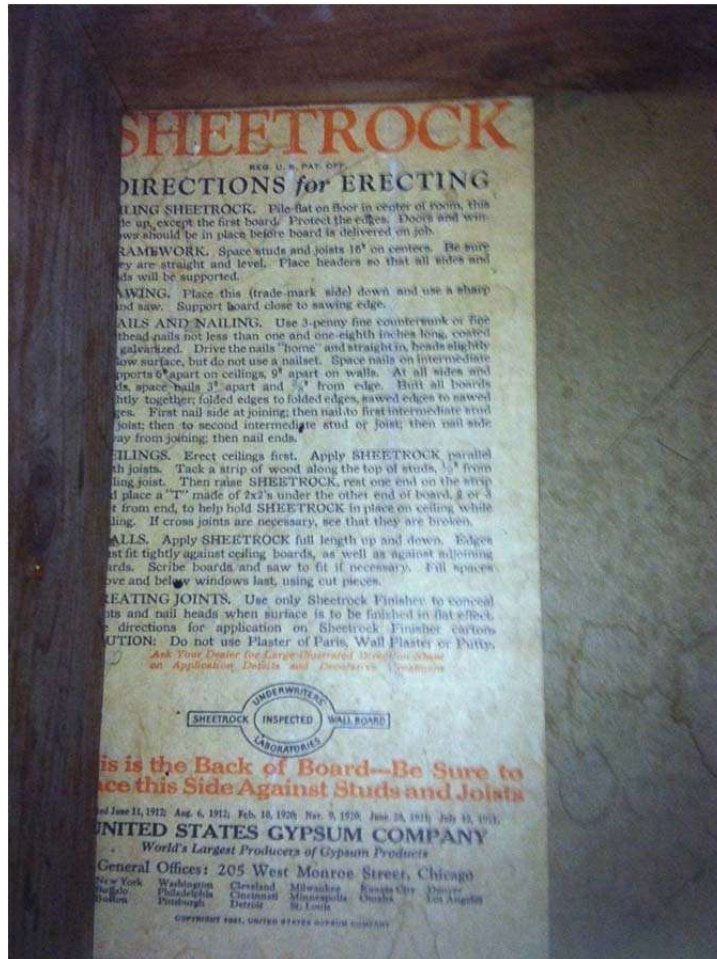
The walls are painted sheetrock from 3 feet 1 inch above the floor to the ceiling. Sheetrock is used to build walls in homes, business and other settings. This product was first developed by the United States Gypsum Company in 1916. It is made primarily out of plaster, but for years it also contained asbestos, which helped to strengthen the boards. USGC did very well with this product, and it was used in structures all over the nation. The very name Sheetrock became synonymous with drywall. This is a very early example of the use of Sheetrock, although developed in 1916 it did not become commonplace in construction until World War II. There is a label on the backside of the Sheetrock which is visible from the attic space. The copyright on the label is 1921 and there is a Denver distribution office listed, so it appears this is indeed an early original example. *[Figure 1]*

Figure 1: Label on early sheetrock found in the attic of the school. The label states that the manufacturer of the material is the United States Gypsum Company, and that the company has a sales office in Denver.
